Journal of the Yeovil Archaeological and Local History Society

THE INSIDE STORY: TOMB REPAIR AND CONSERVATION AT EAST COKER

Brian & Moira Gittos

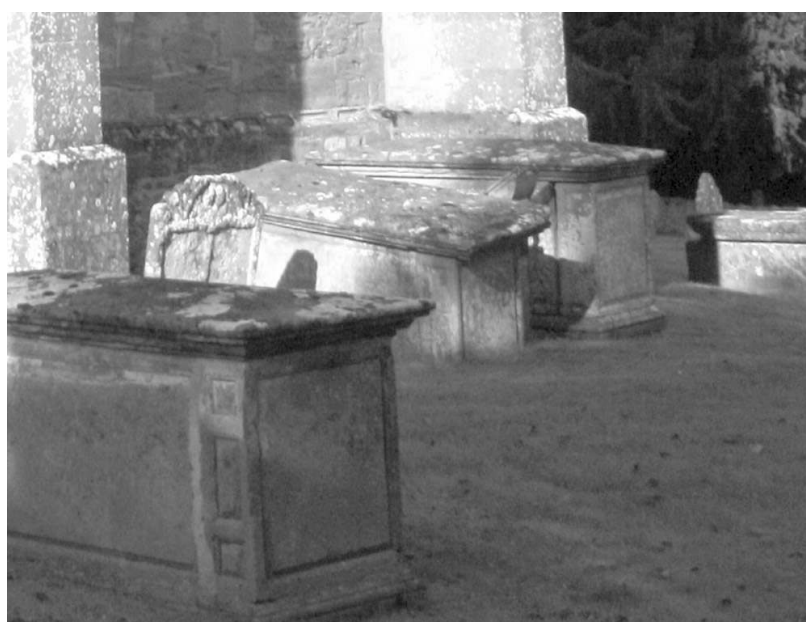
12c

The eighteenth-century tomb chest was entirely constructed from Ham Hill stone. The heavy coped lid, with under moulded edges, was supported by two side and two end panels, that at the east being particularly thick. The base was in separate pieces, also with moulded edges and the whole chest stood above a rectangular, stone-walled chamber. Large slabs of Ham Hill stone covered each end of the chamber, to bear the weight of the chest, with smaller pieces corbelled out over the gap between them. That at the east end had delaminated and broken in the middle: this was the cause of the subsidence. One of the smaller supporting pieces on the north side, was found to be a reused L section resembling a plinth with a moulded edge and integral side wall. It was highly unusual and, locally, badly decayed.

Churchyard tombs at East Coker showing: the location of the Helyar and Cox tomb chests (a); a carved stone panel found in the Helyar tomb (b) and the state of the Cox tomb before conservation (c).

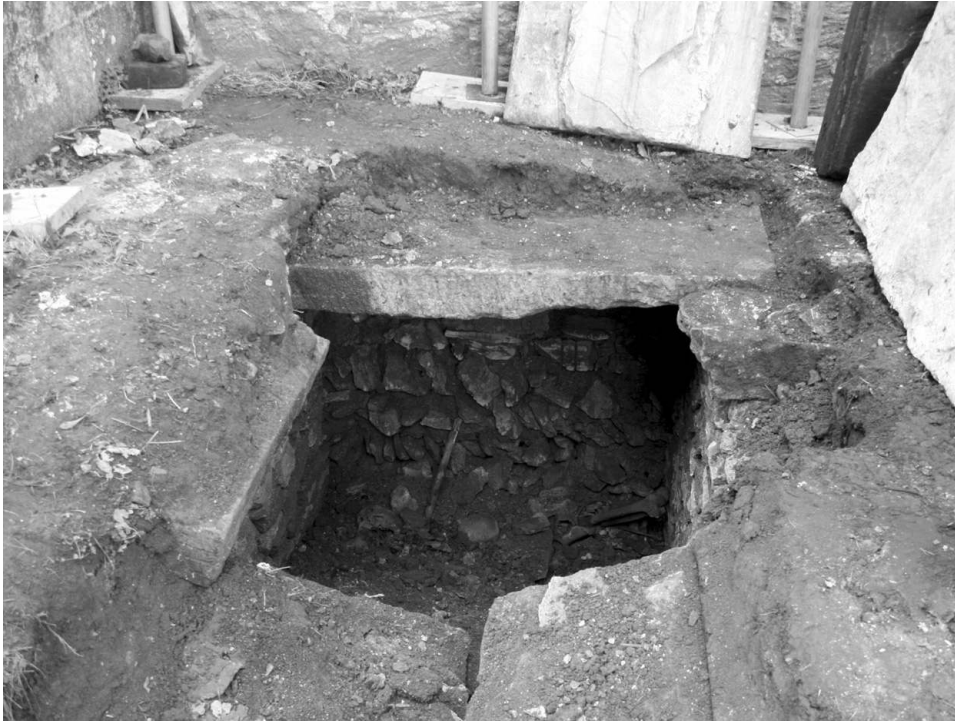
13a

The chamber below (Plate 13a) measured 4 feet (1.23m) wide x 8'10" (2.25m) long. It was partly filled with earth which sloped up towards the east end, so that the original depth was unclear. The side walls and east end wall were of roughly coursed but quite regular dry stone construction, mostly of local limestone but with some pieces of reused Ham Hill stone. The character of the west wall (Plate 13c) was entirely different and appeared to be the footings of the chancel east wall. Both side walls met the west wall at straight joints, with no bonding. The west wall appeared to be of two phases, with the lower part a tumble of loose stone but with a few pitched at an acute angle. The upper phase appeared to have some mortar and was randomly coursed. It was also slightly offset with respect to the lower phase, which was proud by about three inches (7cm). As far as could be judged, the upper part of the west wall was about four inches (10cm) forward of the chancel wall, suggesting a stepped plinth. In the chamber side walls, towards the west end, there were two recesses facing one another that resembled put log holes. That on the south side was capped with a finely worked piece of Ham Hill stone which appeared to be one corner of an opening (Plate 13b). It had a hollow chamfer (including a corner) and another prominent moulding that had been roughly flushed off. There appeared to have been a second pair of holes towards the east end. Higher up the south wall, directly over the worked piece of stone, was another square block of the same material. In the centre of the chamber, was a fallen piece of Ham Hill stone which had a moulded edge exactly matching that of the tomb chest. It had some thick lime mortar on its upper surface.

Plate 13 Conservation of the Cox tomb in progress showing the cavity beneath the tomb chest (a); a putlog hole in the south wall and the foundations of the east wall of the chancel glimpsed at the end of the cavity (c). All photos © B & M Gittos

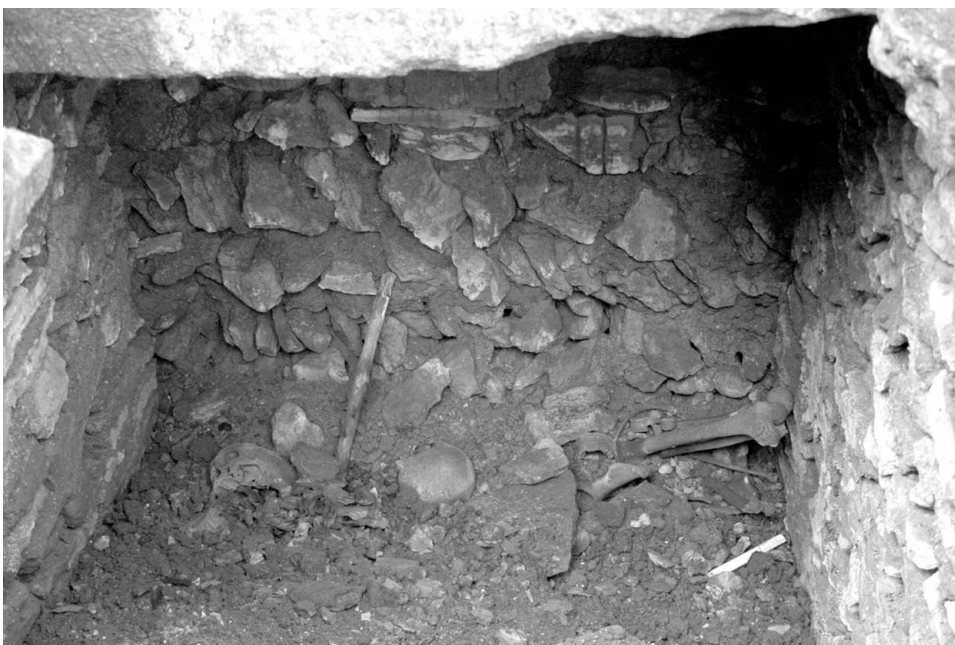
13c

At the west end of the chamber, and at the lowest point of the soil fill, were two skulls lying on their sides, a detached jaw bone with a full set of teeth, a rib, a vertebra and a large femur (see Plate 13c). The latter were randomly located, in the north west corner and may have been pushed into the tomb at a later date. It is uncertain whether the two skulls were in situ. None of these remains were disturbed. It was not intended to carry out any excavation, which would have been the only way to establish a context for the bones. There was no evidence of coffins in the chamber, however decayed, although an iron coffin handle was found at ground level (at the south west end of the chamber, beside the intact western supporting slab). The Kellands had also found a few coffin nails. Some extraneous items had clearly entered the chamber, for example, a length of moulded plastic trunking, the neck of a beer bottle and a lump of pitch. There was also some cement on the north side wall which may have run down from above and was possibly related to the installation of a flood light between this and the neighbouring tomb.

The chancel was reconstructed in the eighteenth-century and it is not known what its relationship is to its predecessor. What was visible inside the tomb appeared to be footings that relate to the present east wall but the hint of pitched stones could imply that this stands on earlier footings. If so, the earlier wall was not apsidal. The Anglo-Saxon west end of the nave still stands² but the location of its eastern counterpart is unknown. The features resembling put log holes in the sides of the chamber probably relate to the way in which the burial ceremony was carried out, providing a temporary resting place for the coffin.
